**CONCEPTUAL SITE MODEL
FORMER ROMIC ENVIRONMENTAL TECHNOLOGIES CORP. FACILITY
LONE BUTTE INDUSTRIAL PARK
GILA RIVER INDIAN COMMUNITY, ARIZONA**

**Clear Creek Associates, PLC
6155 East Indian School Road, Suite 200
Scottsdale, Arizona 85251**

**February 3, 2011
Project No. 212001**

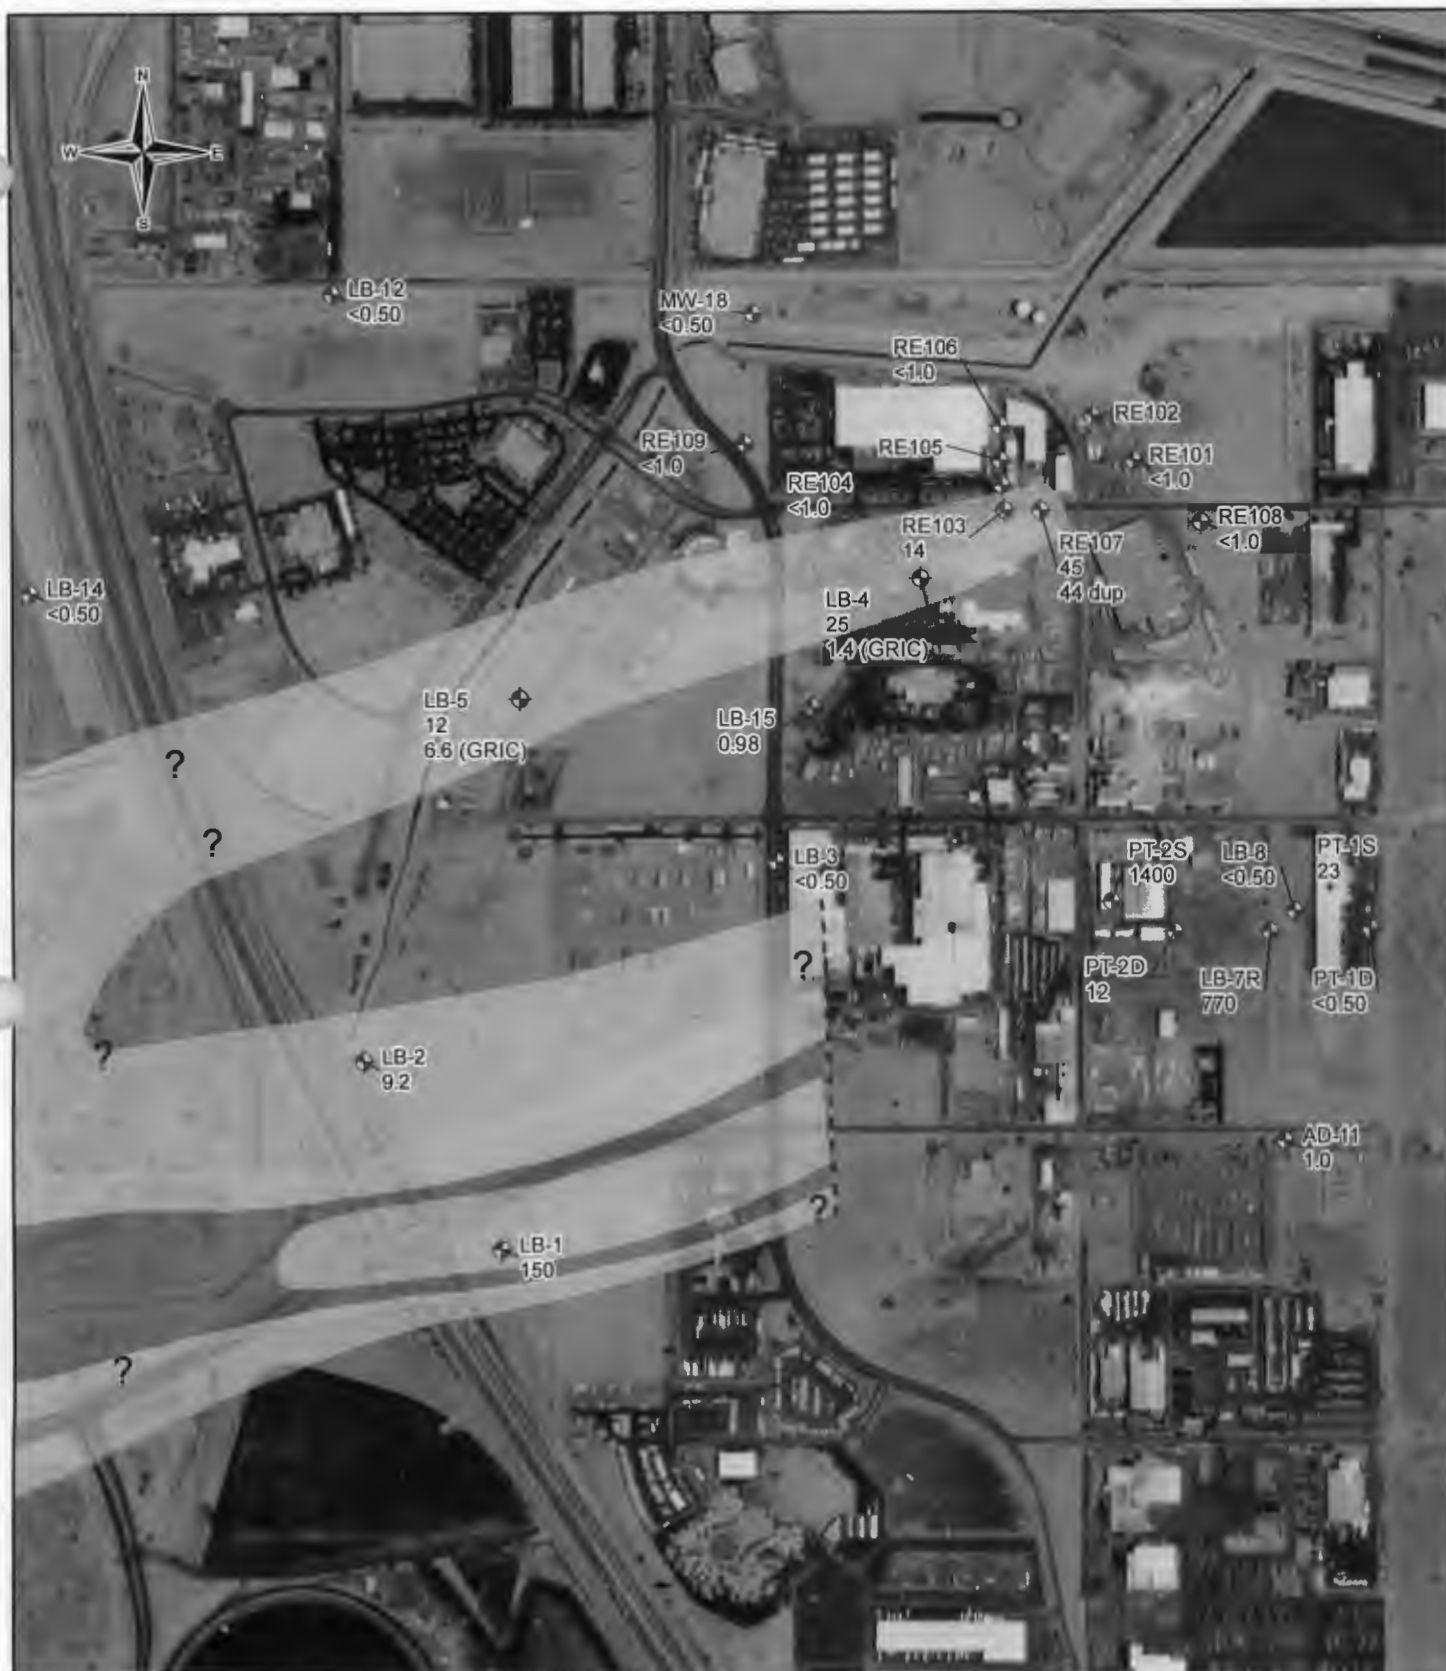
TCE Concentration – Lone Butte Industrial Park Area (July - August 2010)

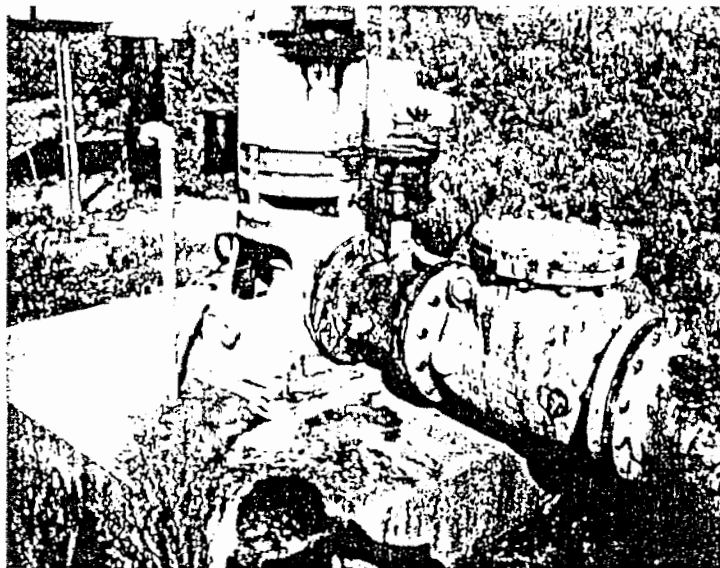
PHOTO 1 taken October 27, 1977. A handle is missing at the hose bibb.

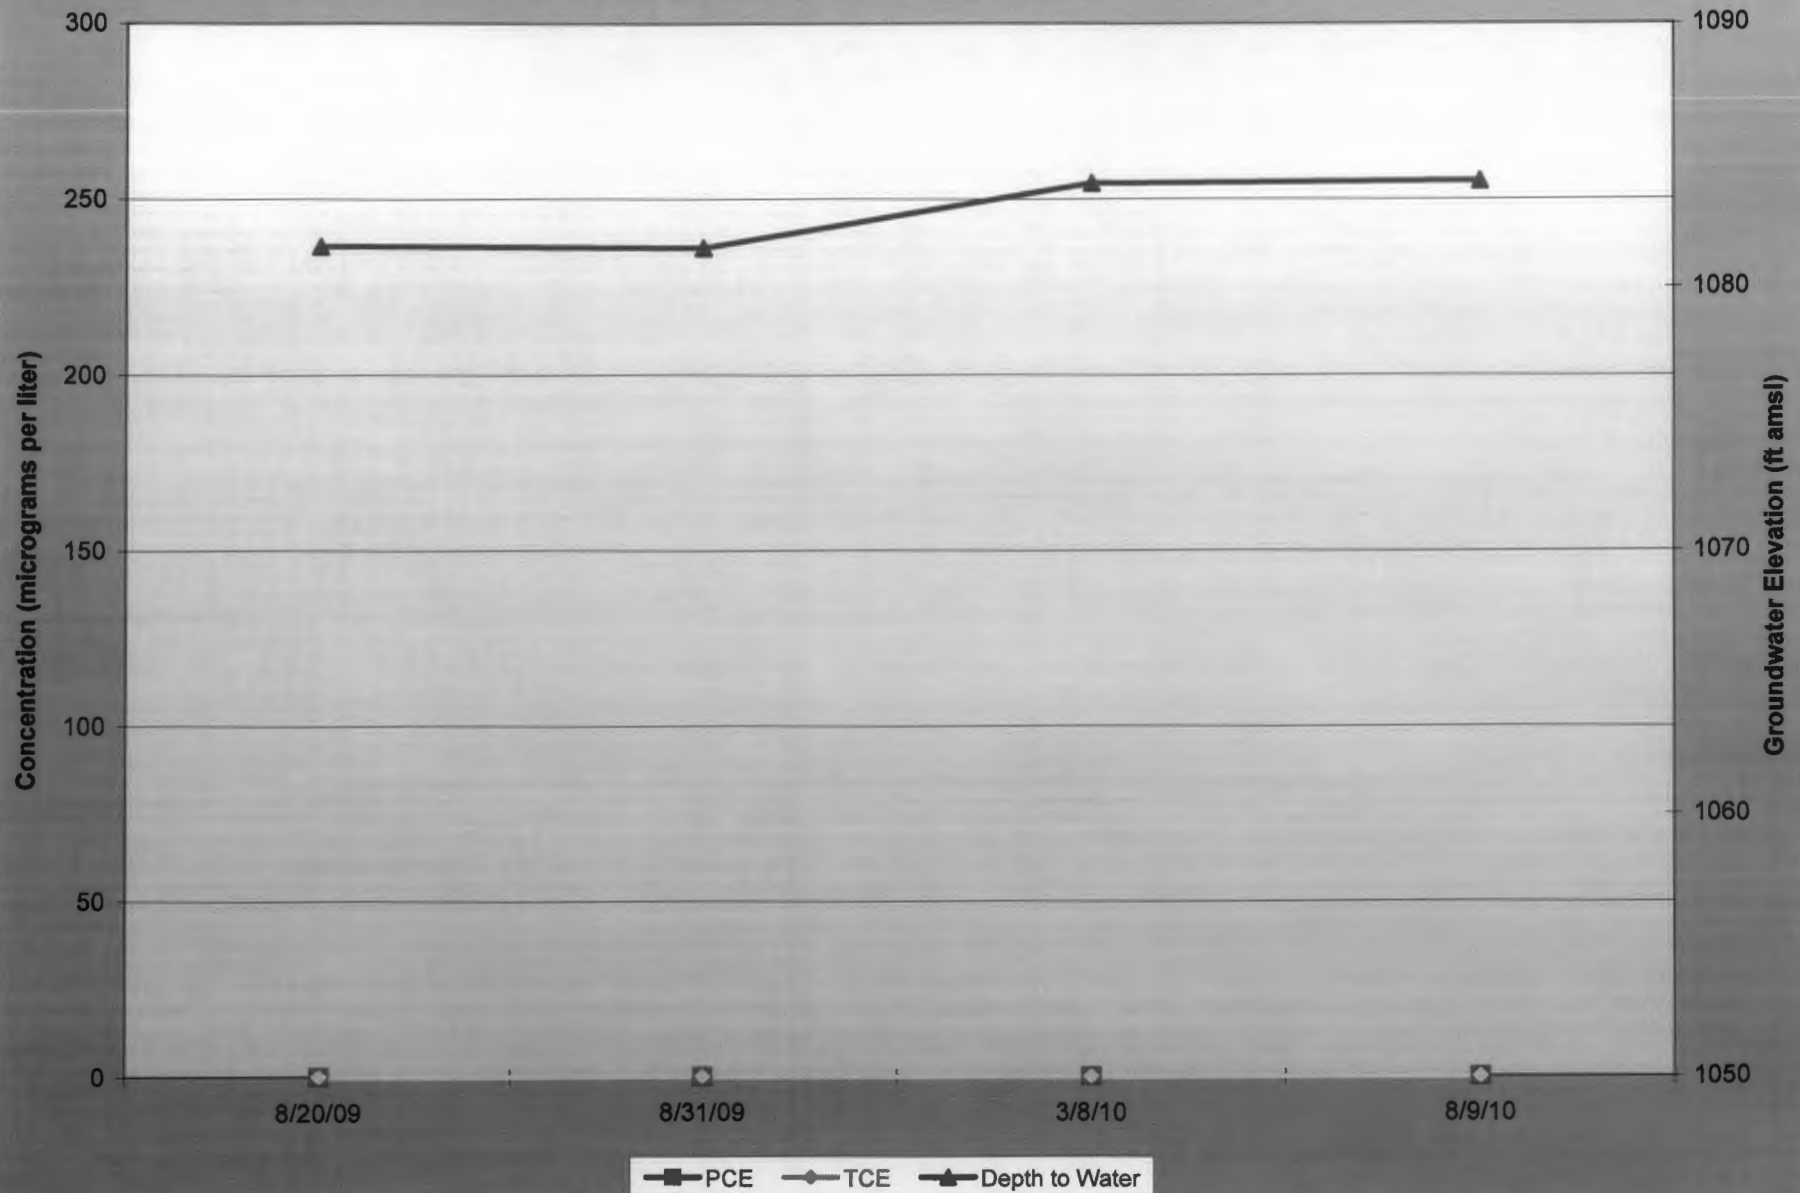
RE109 Water Level and Concentration Data
